REPORT ON THERMAL INSPECTION of the

ELECTRICAL FACILITIES

"Name of Site"

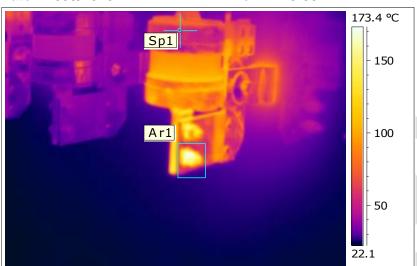
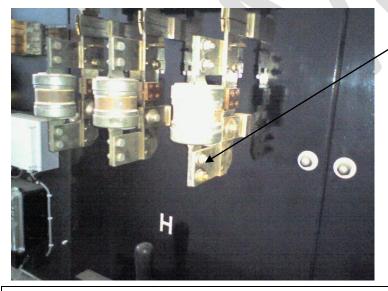
LOCATION	LOCATION "Board Location"	
EQUIPMENT	"Board Name"	
COMPONENT	"Component"	
OBSERVATION	No Abnormal Thermal Activity Detected

Max Temperature	173.1 °C
Ar1 Max. Temperature	173.1 °C
Sp1 Temperature	54.3 °C

Temp. Rise	119
Fault (Ar1 Max) Temp -	1 10
Ref (Sp1) Temp	$^{\circ}C$

Maintain 12 Monthly Inspections:

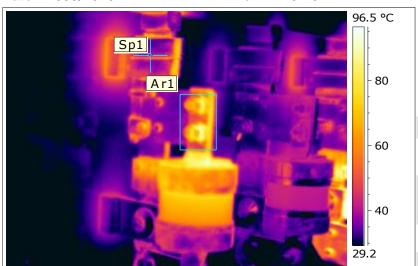
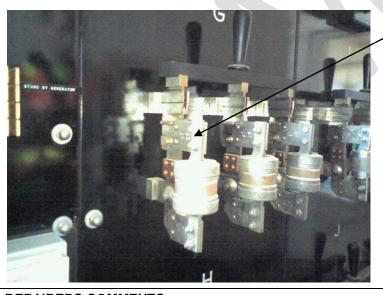
LOCATION	WAREHOUSE	
EQUIPMENT	Main Switch Board	
COMPONENT	HRC Fuse	
OBSERVATION Thermal Activity Detected

Max Temperature	111.7 °C
Ar1 Max. Temperature	91.5 °C
Sp1 Temperature	40.8 °C

Temp. Rise
Fault (Ar1 Max) Temp –
Ref (Sp1) Temp

51 °C

Maintain 12 Monthly Inspections:

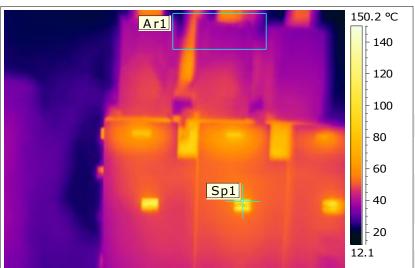
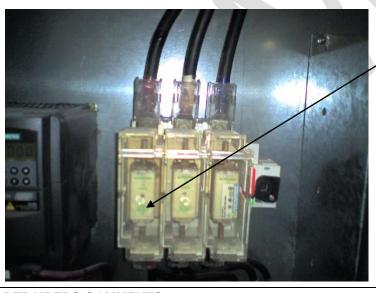
LOCATION	"Board Location"
EQUIPMENT	"Board Name"
COMPONENT "Component"	
OBSERVATION No Abnormal Thermal Activity Detected

Max Temperature	117.7 °C
Ar1 Max. Temperature	57.5 °C
Sp1 Temperature	111.0 °C

Temp. Rise	-53
Fault (Ar1 Max) Temp -	
Ref (Sp1) Temp	$^{\circ}C$

Maintain 12 Monthly Inspections:

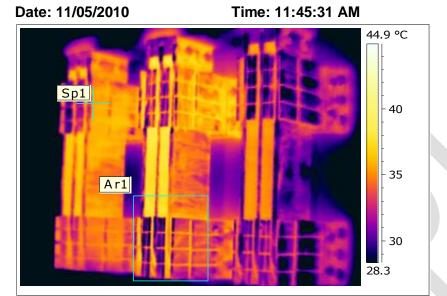
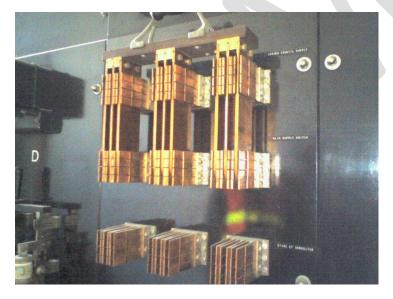
"Component" **OBSERVATION** No Abnormal Thermal Activity Detected

Max Temperature	38.4 °C
Ar1 Max. Temperature	38.1 °C
Sp1 Temperature	35.5 °C

Temp. Rise	
Fault (Ar1 Max) Temp – Ref (Sp1) Temp	3 °C

The temperatures recorded in the Results Table above are the maximum and a reference temperature detected on this equipment: This would be considered to be normal operating temperature and no further action will be necessary:

Maintain 12 Monthly Inspections:
