THERMAL VISION AUSTRALIA

REPORT ON THERMAL INSPECTION
of the
ELECTRICAL FACILITIES
At

"Name of Site"

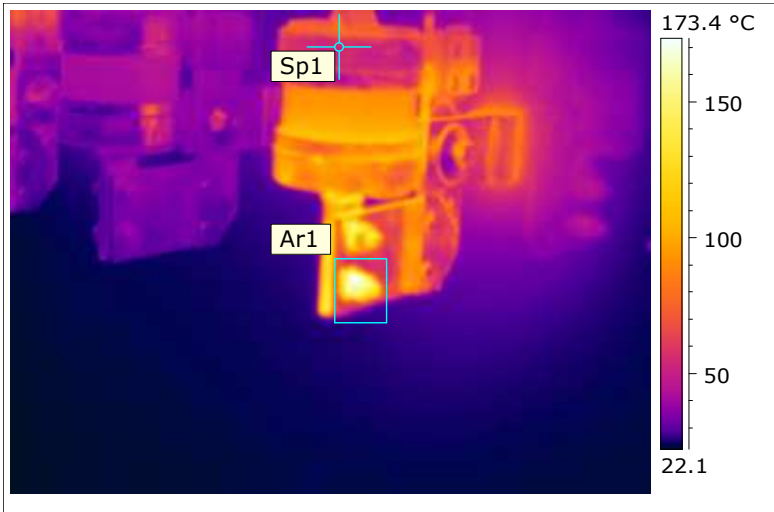
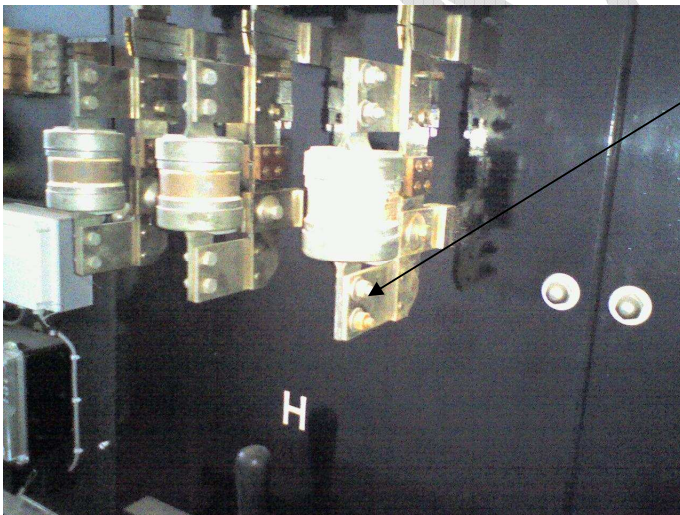
LOCATION	"Board Location"
EQUIPMENT	"Board Name"
COMPONENT	"Component"
OBSERVATION	No Abnormal Thermal Activity Detected

Max Temperature	173.1 °C
Ar1 Max. Temperature	173.1 °C
Sp1 Temperature	54.3 °C

<p>Temp. Rise Fault (Ar1 Max) Temp – Ref (Sp1) Temp</p>	<p>119 °C</p>
--	---

Repair Recommendations
 Maintain 12 Monthly Inspections:

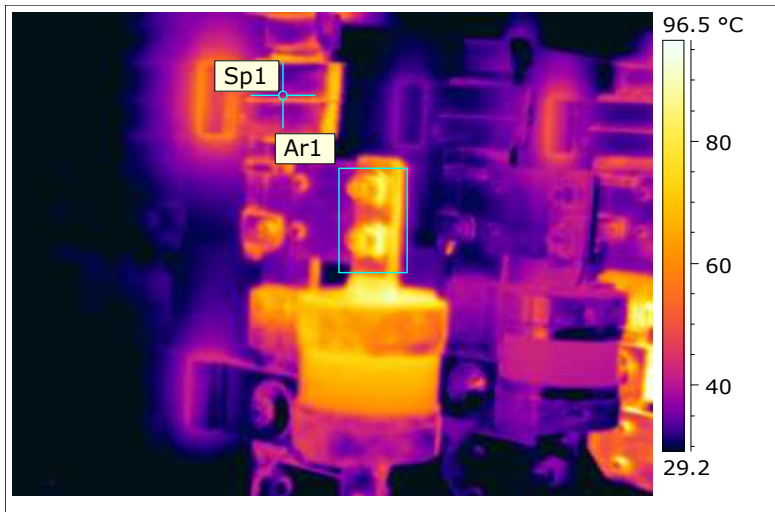
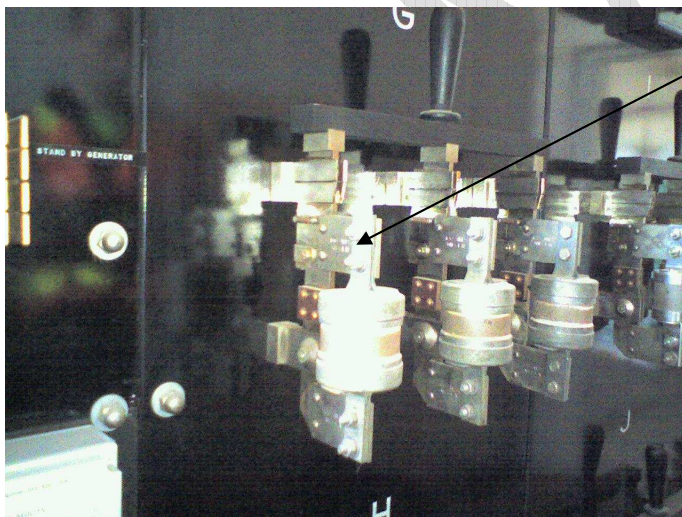
LOCATION	WAREHOUSE
EQUIPMENT	Main Switch Board
COMPONENT	HRC Fuse
OBSERVATION	Thermal Activity Detected

Max Temperature	111.7 °C
Ar1 Max. Temperature	91.5 °C
Sp1 Temperature	40.8 °C

Temp. Rise Fault (Ar1 Max) Temp – Ref (Sp1) Temp	51 °C
---	--------------

Repair Recommendations:
Maintain 12 Monthly Inspections:

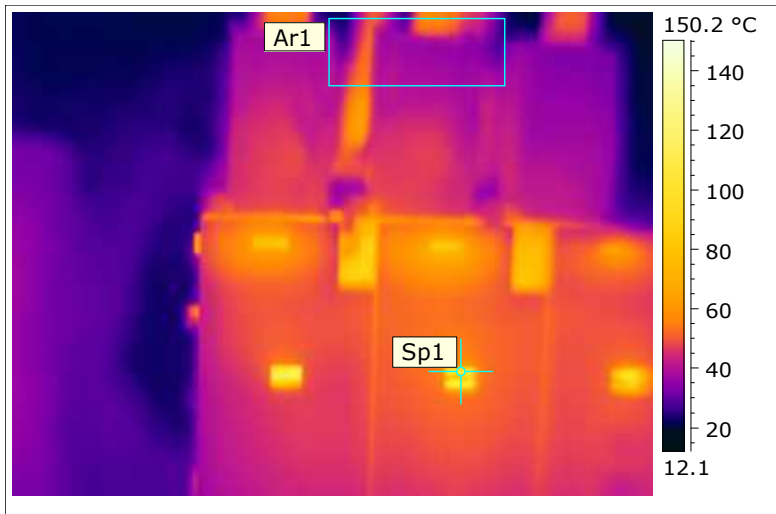
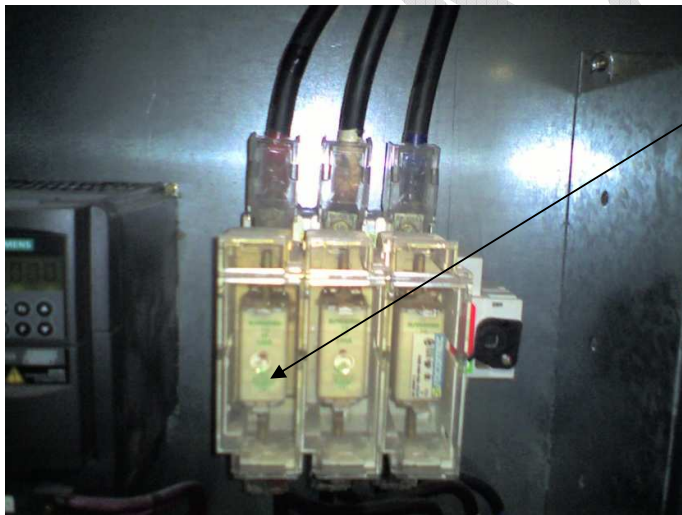
LOCATION	"Board Location"
EQUIPMENT	"Board Name"
COMPONENT	"Component"
OBSERVATION	No Abnormal Thermal Activity Detected

Max Temperature	117.7 °C
Ar1 Max. Temperature	57.5 °C
Sp1 Temperature	111.0 °C

<p>Temp. Rise Fault (Ar1 Max) Temp – Ref (Sp1) Temp</p>	<p>-53 °C</p>
--	--------------------------

Repair recommendations:
Maintain 12 Monthly Inspections:

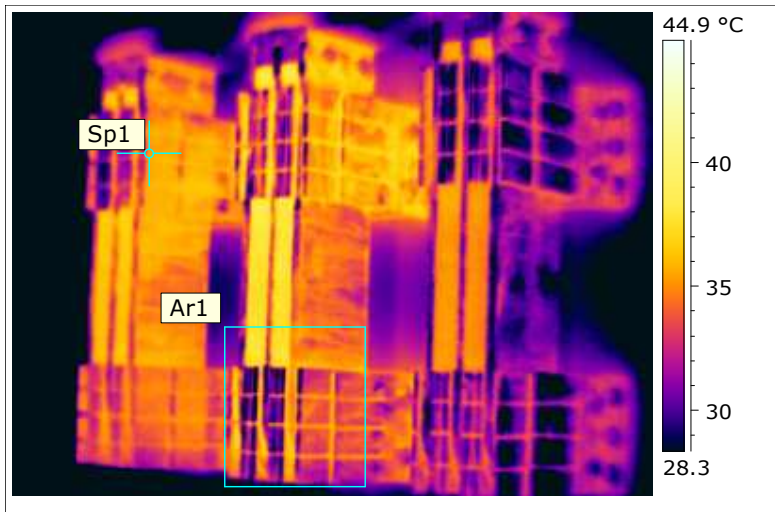
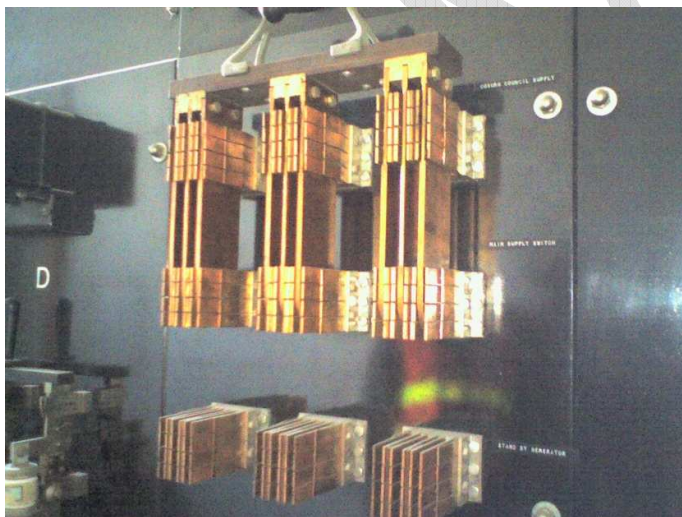
LOCATION	"Board Location"
EQUIPMENT	"Board Name"
COMPONENT	"Component"
OBSERVATION	No Abnormal Thermal Activity Detected

Max Temperature	38.4 °C
Ar1 Max. Temperature	38.1 °C
Sp1 Temperature	35.5 °C

Temp. Rise Fault (Ar1 Max) Temp – Ref (Sp1) Temp	3 °C
---	-------------

The temperatures recorded in the Results Table above are the maximum and a reference temperature detected on this equipment: This would be considered to be normal operating temperature and no further action will be necessary:

Maintain 12 Monthly Inspections:
